**Flood Control Project Maintenance  
Levee Inspections****LMA District Cover Sheet****Spring 2014 Levee Inspection Results****Reclamation District No. 0349 Sutter Island**

**Spring 2014 Levee Inspection Results**

**Reclamation District No. 0349 Sutter Island**

**Levee Inspection Report By Mile - Spring 2014**

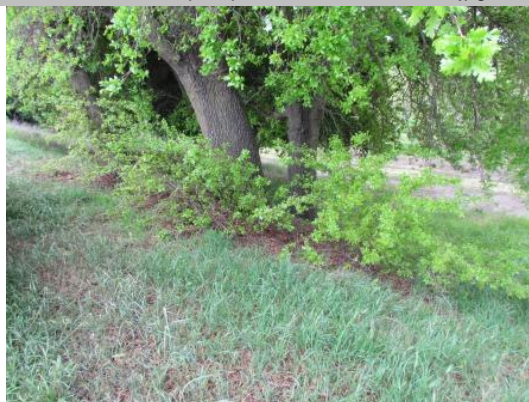
Photo 1 of 1 : phillips\_s\_20140520\_05894.jpg

LM Start	0.87	Rating **	U	Issue No.	32
LM End	0.93	Issue Type +	Ma	Location *	LS
Category	Earthen Levee			GPS Latitude/Longitude	
				Start	End
Item	Vegetation			38.314581 °	38.313901 °
				-121.579133 °	-121.579029 °
DWR ID	DWR_RD0349_01_s _ 2014_32				
Action/Comments					
Trees / Woody Vegetation

Woody tree growth on slope .

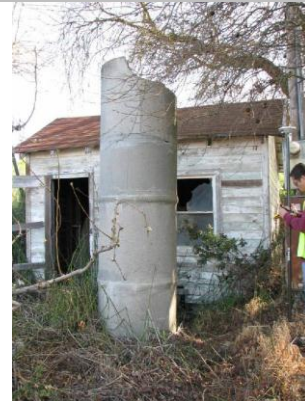
Photo 1 of 1 : UCIP\_2532.jpg

LM Start	0.87	Rating **	M	Issue No.	22
LM End	0.87	Issue Type +	En	Location *	LS
Category	Supplemental			GPS Latitude/Longitude	
				Start	End
Item	DWR UCIP Field Study			38.314672 °	38.314672 °
				-121.579102 °	-121.579102 °
DWR ID	DWR_RD0349_01_s _ 2014_22				
Action/Comments					
Inspector Comments: FS_ID:21572					
EP_NO: N/A					
Repair Type:					
Crossing Status:					
UCIP Comments: No records were found during intial desk study--need to contact owner to obtain permit number authorizing work. If crossing is no longer used by owner, the owner will need to coordinate with DWR Inspector and CVFPB to remove crossing according to Title 23 requirements. Dense vegetation limits the inspector's visibility to identify signs of pipe failure (leaks) along the slope. Recommend removing vegetation along pipe alignment to conduct proper inspection of structure and appurtenances. Note date on photos should be 3/18/09 not 7/26/08 camera metadata is incorrect.

FIELD_STRUCT_DESC: Abandoned 8-inch pipe through the levee, 13.9 feet below the crown. Pump on platform at landward toe. Service pole on landward slope.					
FS Date: 3/18/2009

View of pump house, concrete stand pipe, and utility pole.

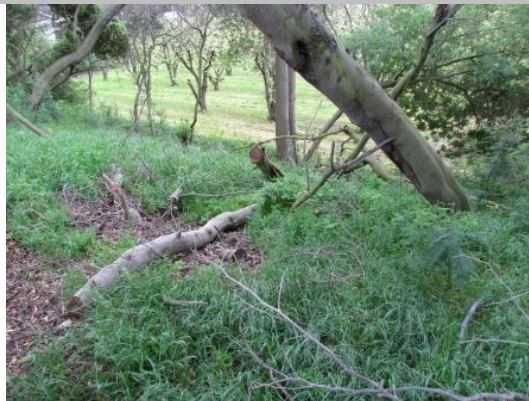
Photo 1 of 1 : phillips\_s\_20140520\_05895.jpg

LM Start	1.24	Rating **	U	Issue No.	35
LM End	1.24	Issue Type +	En	Location *	LS
Category	Earthen Levee			GPS Latitude/Longitude	
				Start	End
Item	Encroachments			38.309643 °	38.309643 °
				-121.577271 °	-121.577271 °
DWR ID	DWR_RD0349_01_s _ 2014_35				
Action/Comments					
Tree or limb

Fallen tree on landward slope, cut up and remove from levee section.

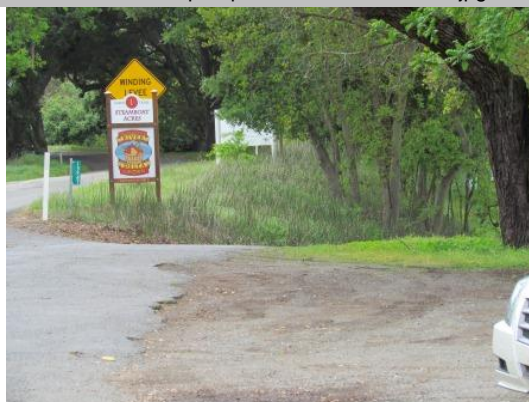
Photo 1 of 1 : phillips\_s\_20140520\_05898.jpg

Sutter Slough levee mile 0.00 looking downstream from landside shoulder. Photo taken 3-27-2014.

Control annual grass and weeds on the levee slopes and easements.

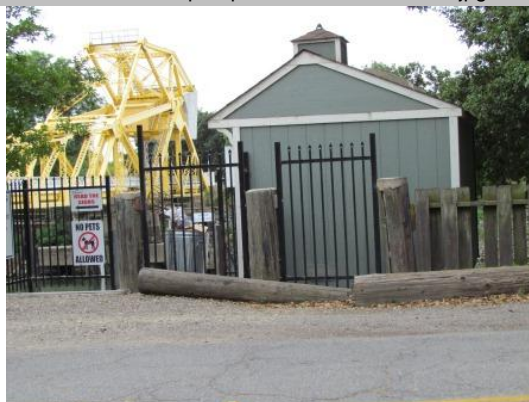
Photo 1 of 2 : phillips\_s\_20140520\_05899.jpg

LM Start	0.02	Rating **	U	Issue No.	4
LM End	0.02	Issue Type +	En	Location *	WS
Category	Earthen Levee			GPS Latitude/Longitude	
				Start	End
Item	Encroachments			38.304870 °	38.304870 °
				121.574730 °	121.574730 °
DWR ID	DWR_RD0349_02_s _ 2012_4				
Action/Comments					
Building					
Inspector Comments: This encroachment along the waterward slope was not authorized by the CVFPB. There are multiple encroachments at this site. Owner working with CVFPB to get permits. 11-2013. The works are still pending 2014.

Unauthorized building waterside shoulder Unit 2 Sutter Slough.

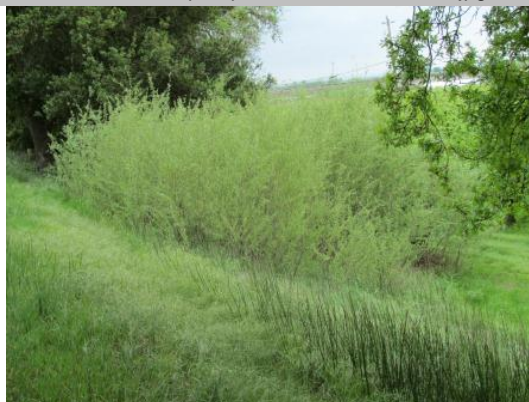
Photo 1 of 1 : phillips\_s\_20140520\_05901.jpg

LM Start	0.34	Rating **	U	Issue No.	95
LM End	0.34	Issue Type +	Ma	Location *	LS
Category	Earthen Levee			GPS Latitude/Longitude	
				Start	End
Item	Vegetation			38.302358 °	38.302358 °
				-121.579710 °	-121.579710 °
DWR ID	DWR_RD0349_02_s_2014_95				
Action/Comments					
Remove the wild growth other than native grasses from the levee slopes.					
Inspector Comments: These young trees need to be removed from the levee section.

Unwanted wild growth of willow trees on landside slope and toe.

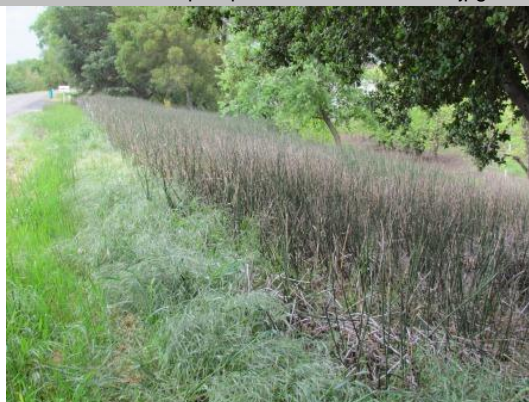
Photo 1 of 1 : phillips\_s\_20140520\_05908.jpg

LM Start	0.84	Rating **	U	Issue No.	77
LM End	0.96	Issue Type +	Ma	Location *	LS
Category	Earthen Levee			GPS Latitude/Longitude	
				Start	End
Item	Vegetation			38.295708 °	38.294014 °
				-121.582920 °	-121.583411 °
DWR ID	DWR_RD0349_02_s _ 2014_77				
Action/Comments					
Remove the wild growth other than native grasses from the levee slopes.					
Inspector Comments: Growth taller than 24 inches, (horse tail).

Unwanted tall reid grasses on the landward slope.

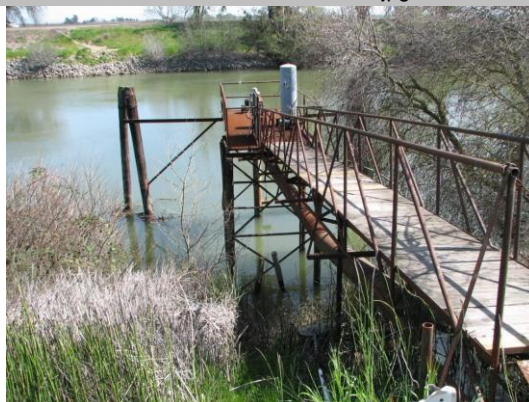
Photo 1 of 1 : UCIP\_2574.jpg

LM Start	1.08	Rating **	M	Issue No.	62
LM End	1.08	Issue Type +	En	Location *	WS
Category	Supplemental			GPS Latitude/Longitude	
				Start	End
Item	DWR UCIP Field Study			38.292411 °	38.292411 °
				-121.583897 °	-121.583897 °
DWR ID	DWR_RD0349_02_s _ 2014_62				
Action/Comments					
Inspector Comments: FS_ID:21605 EP_NO: N/A Repair Type: Crossing Status: UCIP Comments: Dense vegetation limits the inspector's visibility to identify signs of pipe failure (leaks) through the levee slopes. Recommend removing vegetation along pipe alignment to conduct proper inspection of structure and appurtenances. FIELD_STRUCT_DESC: 1 of 2: 12-inch pipe and electrical conduit through the levee, both 4.0 feet below the crown. Pump on pile structure in the stream with walkway. Hand primer pump in pumphouse and power pole at the landward toe. Concrete standpipes and distribution boxes with gates at landward toe. (USACE-1959). This entry matches the Drainage or Irrigation Structure referenced in O&M manual (HLM 1.1). Pumphouse relocated and electrical conduit installed under Permit No. 5487 (1967). FS Date: 3/18/2009

Overview of crossing from waterward side.

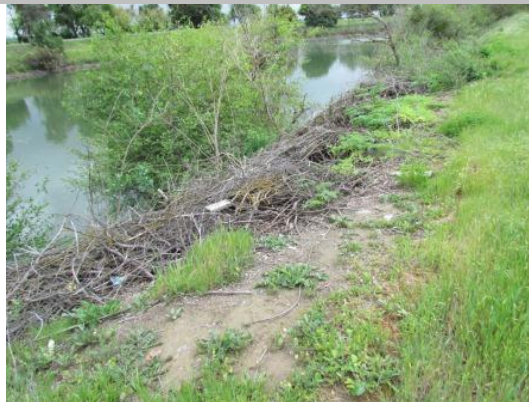
Photo 1 of 1 : phillips\_s\_20140520\_05905.jpg

LM Start	1.14	Rating **	U	Issue No.	82
LM End	1.34	Issue Type +	En	Location *	WS
Category	Earthen Levee			GPS Latitude/Longitude	
				Start	End
Item	Encroachments			38.291501 °	38.288734 °
				-121.584165 °	-121.584013 °
DWR ID	DWR_RD0349_02_s _ 2014_82				
Action/Comments					
Prunings

Tree trimmings at waters edge blocking view of bank.

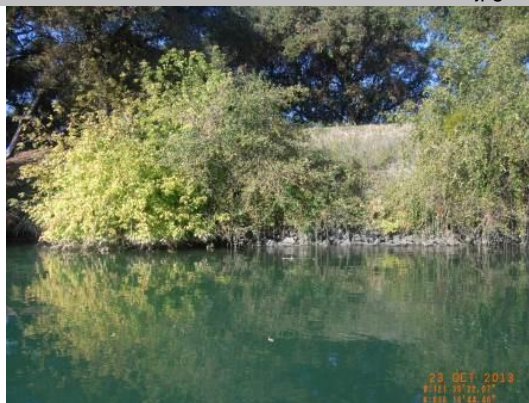
Photo 1 of 1 : USACE2013A\_STM\_23-9\_R\_5.jpg

LM Start	2.00	Rating **	M	Issue No.	21
LM End	2.15	Issue Type +	Ma	Location *	WS
Category	Supplemental			GPS Latitude/Longitude	
				Start	End
Item	USACE Erosion Survey			38.279017 °	38.278597 °
				-121.589615 °	-121.589854 °
DWR ID					
Action/Comments					
Inspector Comments: 1997 - Top right bank has retreated into the levee. Site is between two rock sites. 1999 - Downstream half of the reach repaired with rock. 2000 - Trees leaning into the water. 2010 - Site appears worse. 2011 - New erosion at the toe. 2013: Short vertical sections observed at upstream end. [2013 Site ID: STM_23-9_R]

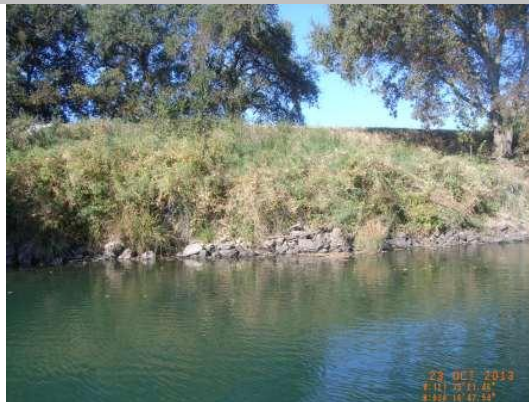
Photo 1 of 1 : USACE2013A\_STM\_24-1\_R\_1.jpg

LM Start	2.05	Rating **	M	Issue No.	23
LM End	2.05	Issue Type +	Ma	Location *	WS
Category	Supplemental			GPS Latitude/Longitude	
				Start	End
Item	USACE Erosion Survey			38.280069 °	38.279919 °
				-121.589443 °	-121.589438 °
DWR ID					
Action/Comments					
Inspector Comments: 2011 - Small scallop caused by erosion and wave wash. 2013: No observed changes. [2013 Site ID: STM 24-1 R]

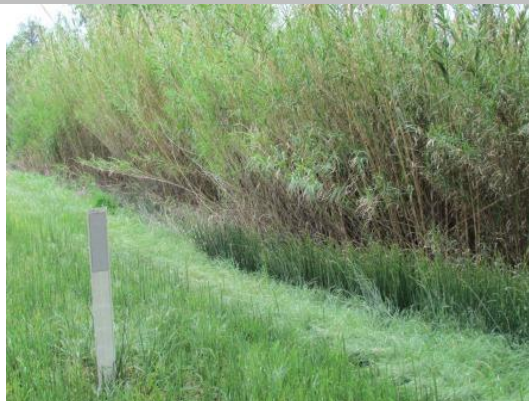
Photo 1 of 1 : phillips\_s\_20140520\_05911.jpg

LM Start	2.37	Rating **	U	Issue No.	88
LM End	2.39	Issue Type +	Ma	Location *	LS
Category	Earthen Levee			GPS Latitude/Longitude	
				Start	End
Item	Vegetation			38.275784 °	38.275690 °
				-121.591359 °	-121.591322 °
DWR ID	DWR_RD0349_02_s _ 2014_88				
Action/Comments					
Remove the wild growth other than native grasses from the levee slopes.					
Inspector Comments: Bambo on landside slope and toe levee 2.39.

Levee toe taken over by wild growth of bambo.

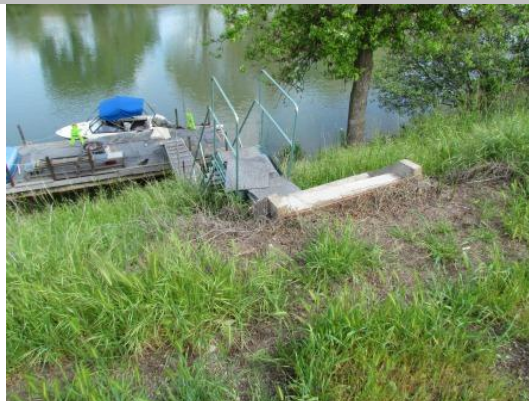
Photo 1 of 2 : phillips\_s\_20140520\_05914.jpg

LM Start	2.43	Rating **	U	Issue No.	1
LM End	2.43	Issue Type +	Ma	Location *	WS
Category	Earthen Levee			GPS Latitude/Longitude	
				Start	End
Item	Encroachments			38.275403 °	38.275403 °
				-121.591229 °	-121.591229 °
DWR ID	DWR_RD0349_02_f_2013_1				
Action/Comments					
Stairway Inspector Comments: The landowner has installed steps on the waterside slope and has an unauthorized boat dock anchored to the waterside slope.

Unsatisfactory steps placed on waterward slope and toe.

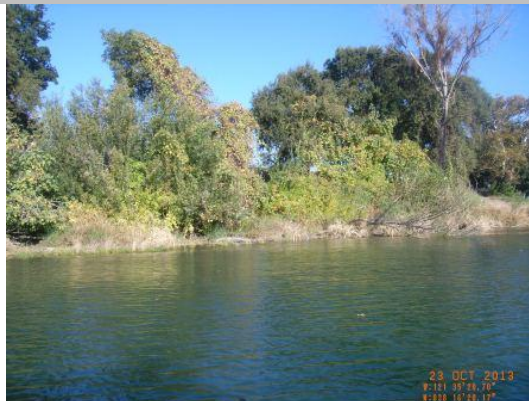
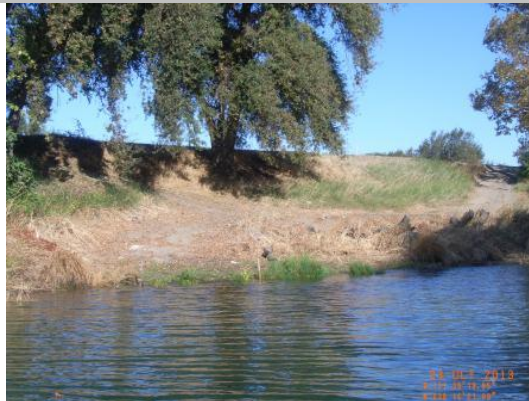
LM Start	2.46	Rating **	M	Issue No.	19
LM End	2.70	Issue Type +	Ma	Location *	WS
Category	Supplemental			GPS Latitude/Longitude	
				Start	End
Item	USACE Erosion Survey			38.273854 °	38.271998 °
				-121.588745 °	-121.589424 °
DWR ID					
Action/Comments					
Inspector Comments: 2011 - Toe scour at the tidal zone. 2013: No observed changes. [2013 Site ID: STM_23-6_R]

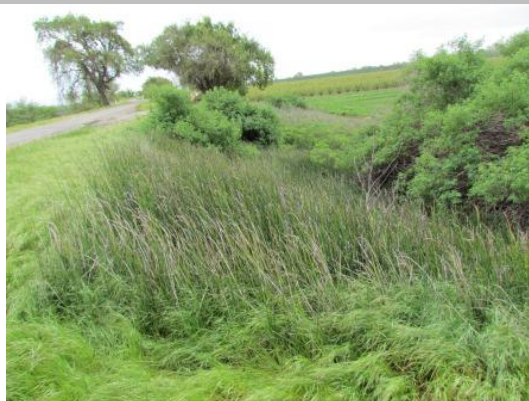
Photo 1 of 1 : phillips\_s\_20140520\_05910.jpg

LM Start	2.89	Rating **	U	Issue No.	91
LM End	2.90	Issue Type +	Ma	Location *	LS
Category	Earthen Levee			GPS Latitude/Longitude	
				Start	End
Item	Vegetation			38.269510 °	38.269276 °
				-121.589801 °	-121.589730 °
DWR ID	DWR_RD0349_02_s_2014_91				
Action/Comments					
Remove the wild growth other than native grasses from the levee slopes.

Unsatisfactory wild growth on the landside levee slope and toe.

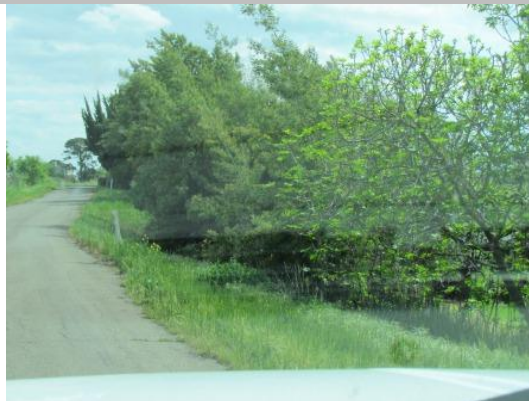
Photo 1 of 1 : phillips\_s\_20140521\_05918.jpg

LM Start	3.03	Rating **	U	Issue No.	53
LM End	3.04	Issue Type +	Ma	Location *	LS
Category	Earthen Levee			GPS Latitude/Longitude	
				Start	End
Item	Trim / Thin Trees			38.267663 °	38.267418 °
				-121.588779 °	-121.588660 °
DWR ID	DWR_RD0349_02_s _ 2013_53				
Action/Comments					
Thin trees to allow visibility of the ground and room to flood fight.

Overgrown trees blocking view of the landside levee slope.

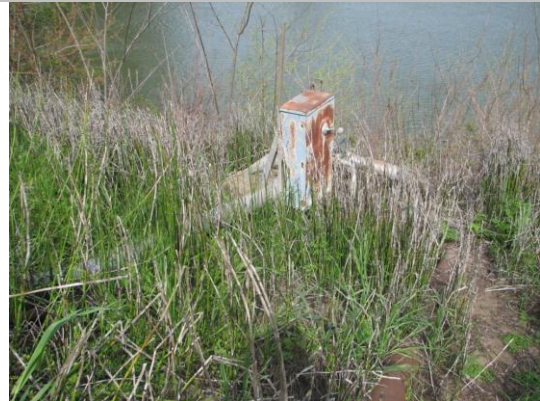
Photo 1 of 1 : UCIP\_2602.jpg

FIELD_STRUCT_DESC: 8-inch steel pipe and 2-inch iron electrical conduit through the levee, both 3.7 feet below the crown. Siphon breaker in protective housing on waterward slope. Pump and switch panel on concrete blocks on the waterward slope. Service pole on landward slope. (Permit No. 5350-1966)					
FS Date: 3/18/2009

View of waterward side--control panel and pipe.

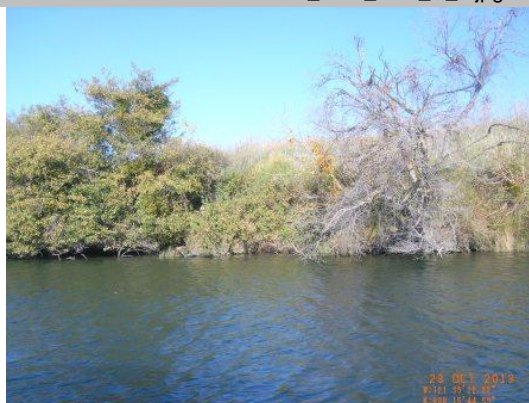
Photo 1 of 1 : USACE2013A\_STM\_22-8\_R\_6.jpg

LM Start	3.25	Rating **	M	Issue No.	3
LM End	3.47	Issue Type +	Ma	Location *	WS
Category	Supplemental			GPS Latitude/Longitude	
				Start	End
Item	USACE Erosion Survey			38.262510 °	38.262533 °
				-121.589481 °	-121.591690 °
DWR ID					
Action/Comments					
Inspector Comments: 2010 - Slumping sections on the lower bank, appears to be scouring around the trees. 2011 - Soil beach at toe. 2013: No observed changes. [2013 Site ID: STM_22-8_R]

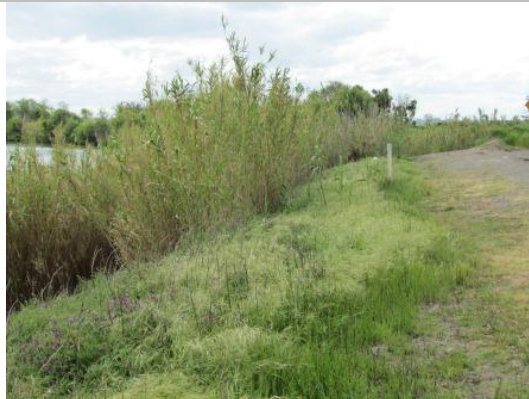
Photo 1 of 1 : phillips\_s\_20140521\_05920.jpg

LM Start	4.32	Rating **	U	Issue No.	60
LM End	4.34	Issue Type +	Ma	Location *	WS
Category	Earthen Levee			GPS Latitude/Longitude	
				Start	End
Item	Vegetation			38.254767 °	38.254718 °
				-121.599670 °	-121.599843 °
DWR ID	DWR_RD0349_02_f_2013_60				
Action/Comments					
Remove the wild growth other than native grasses from the levee slopes.					
Inspector Comments: This bamboo need to be removed from the levee section.

Remove the unwanted wild growth of bamboo from the levee section.

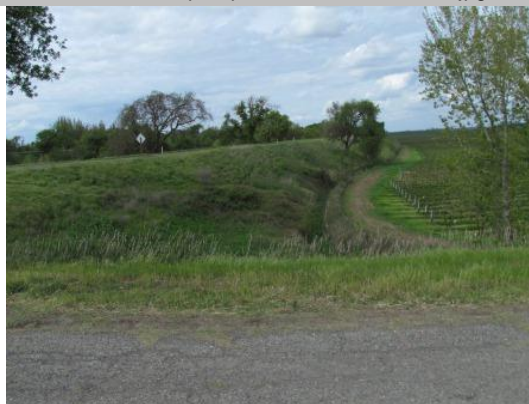
Photo 1 of 1 : phillips\_s\_20140521\_05921.jpg

LM Start	0.03	Rating **	U	Issue No.	6
LM End	0.03	Issue Type +	Ma	Location *	LS
Category	Earthen Levee			GPS Latitude/Longitude	
				Start	End
Item	Vegetation			38.255206 °	38.255206 °
				-121.600080 °	-121.600080 °
DWR ID	DWR_RD0349_03_f_2013_6				
Action/Comments					
Remove the wild growth other than native grasses from the levee slopes.

RD 349 Unit 3 looking downstream from levee mile 0.03 landside.

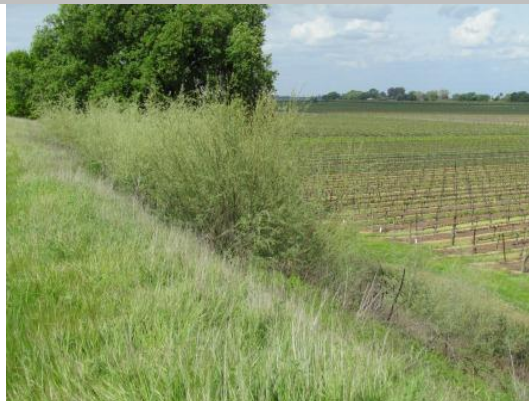
Photo 1 of 1 : phillips\_s\_20140521\_05922.jpg

LM Start	0.08	Rating **	U	Issue No.	7
LM End	0.19	Issue Type +	Ma	Location *	LS
Category	Earthen Levee			GPS Latitude/Longitude	
				Start	End
Item	Vegetation			38.255926 °	38.257581 °
				-121.599950 °	-121.599783 °
DWR ID	DWR_RD0349_03_f_2013_7				
Action/Comments					
Trees / Woody Vegetation

Woody growth of young willows on landside slope and toe.

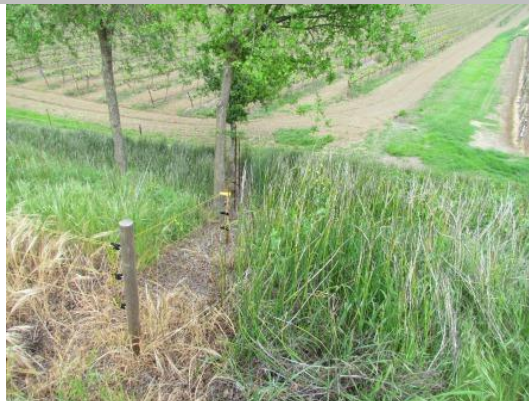
Photo 2 of 2 : phillips\_s\_20140521\_05924.jpg

LM Start	0.48	Rating **	U	Issue No.	60 (cont)
LM End	0.69	Issue Type +	En	Location *	LS
Category	Earthen Levee			GPS Latitude/Longitude	
				Start	End
Item	Encroachments			38.261763 °	38.264650 °
				-121.600695 °	-121.601304 °
DWR ID	DWR_RD0349_03_s_2014_60				
Action/Comments					
Fence					
Inspector Comments: There is no permit for this electric fence on the landside levee section. It should be removed.

View of fence along the levee slope from shoulder to levee toe running along downstream.

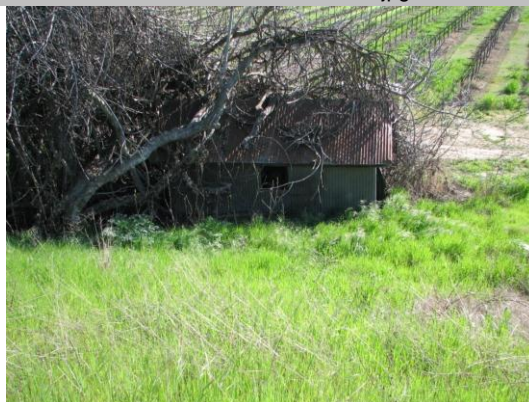
Photo 1 of 1 : UCIP\_2626.jpg

LM Start	0.77	Rating **	M	Issue No.	28
LM End	0.77	Issue Type +	En	Location *	LS
Category	Supplemental			GPS Latitude/Longitude	
				Start	End
Item	DWR UCIP Field Study			38.265705 °	38.265705 °
				-121.601644 °	-121.601644 °
DWR ID	DWR_RD0349_03_s_2014_28				
Action/Comments					
Inspector Comments: FS_ID:21624					
EP_NO: N/A					
Repair Type:					
Crossing Status:					
UCIP Comments: Need to find owner and notify of pipe deterioration.					
Owner will need to replace or remove per CVFPB Title 23 requirements.					
Dense vegetation limits the inspector's visibility to identify signs of pipe					
failure (leaks) through the levee slopes. Recommend removing					
vegetation along pipe alignment to conduct proper inspection of					
structure and appurtenances. Note date on photos should be 3/18/09					
not 7/26/08 camera metadata is incorrect.					
FIELD_STRUCT_DESC: 8-inch pipe through the levee, 2.4 feet below

the crown. Pump and gate valve in a pumphouse at the landward toe.					
Concrete standpipe on landward side.					
FS Date: 3/19/2009

Pump house located at the landward toe.

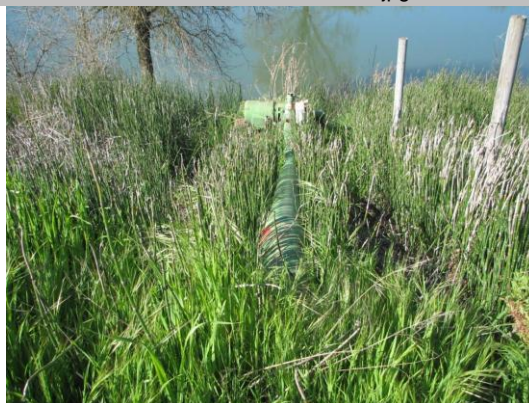
Photo 1 of 1 : UCIP\_2712.jpg

LM Start	0.91	Rating **	M	Issue No.	29
LM End	0.91	Issue Type +	En	Location *	LS
Category	Supplemental			GPS Latitude/Longitude	
				Start	End
Item	DWR UCIP Field Study			38.267620 °	38.267620 °
				-121.602458 °	-121.602458 °
DWR ID	DWR_RD0349_03_s _ 2014_29				
Action/Comments					
Inspector Comments: FS_ID:21673					
EP_NO: N/A					
Repair Type:					
Crossing Status:					
UCIP Comments: No records were found during initial desk study--need to contact owner to obtain permit number authorizing work. Unable to determine if filter system is part of crossing appurtenances. If crossing is no longer used by owner, the owner will need to coordinate with DWR Inspector and CVFPB to remove crossing according to Title 23 requirements. Dense vegetation limits the inspector's visibility to identify signs of pipe failure (leaks) through the levee slopes. Recommend removing vegetation along pipe alignment to conduct proper inspection of structure and appurtenances. Note date on photos should be 3/18/09 not 7/26/08 camera metadata is incorrect.

FIELD_STRUCT_DESC: 12-inch pipe through the levee, approximately 2.0 feet below the crown. Pipe changes diameter, 10-inch along both shoulders and 8-inch diameter exit on waterward side. Pipe exposed along both slopes. Pump on waterward side. Filtration system and power pole on landward side. Rock revetment on waterward slope.					
FS Date: 10/3/2013 9:42:00 AM

View of waterward side--pipe and pump.

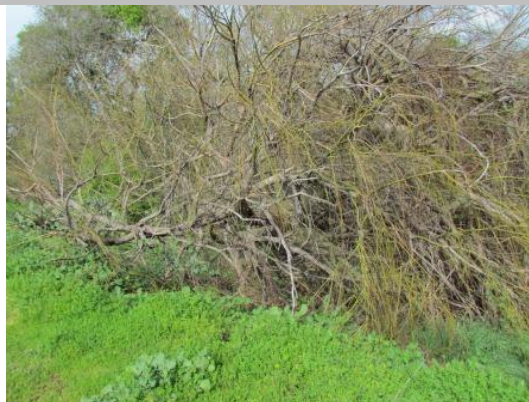
Photo 1 of 1 : phillips\_s\_20140521\_05925.jpg

LM Start	0.91	Rating **	U	Issue No.	61
LM End	0.91	Issue Type +	Ma	Location *	LS
Category	Earthen Levee			GPS Latitude/Longitude	
				Start	End
Item	Trim / Thin Trees			38.267656 °	38.267656 °
				-121.602449 °	-121.602449 °
DWR ID	DWR_RD0349_03_s _ 2014_61				
Action/Comments					
Thin trees to allow visibility of the ground and room to flood fight.

Tree blocking view of landward levee section. Thin and trim up to view levee slope.

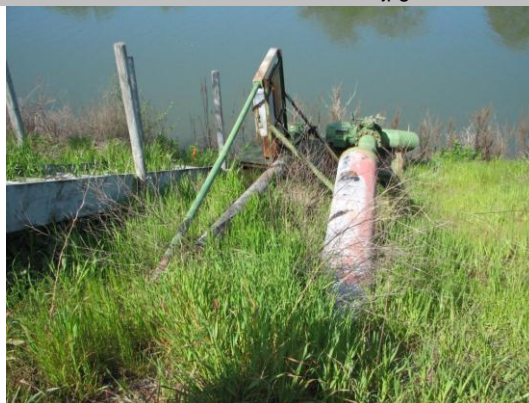
Photo 1 of 1 : UCIP\_2717.jpg

LM Start	1.27	Rating **	M	Issue No.	31
LM End	1.27	Issue Type +	En	Location *	LS
Category	Supplemental			GPS Latitude/Longitude	
				Start	End
Item	DWR UCIP Field Study			38.272532 °	38.272532 °
				-121.603039 °	-121.603039 °
DWR ID	DWR_RD0349_03_s_2014_31				
Action/Comments					
Inspector Comments: FS_ID:21675					
EP_NO: 11744					
Repair Type:					
Crossing Status:					
UCIP Comments: Dense vegetation limits the inspector's visibility to identify signs of pipe failure (leaks) through the levee slopes.					
Recommend removing vegetation along pipe alignment to conduct proper inspection of structure and appurtenances. Note date on photos should be 3/18/09 not 7/26/08 camera metadata is incorrect.					
FIELD_STRUCT_DESC: 1 of 2: 14-inch steel irrigation pipe and 2-inch electric conduit through the levee, both 4.4 feet below the crown.					
Reduced to 12-inch steel pipe under both levee slopes. Steel cutoff wall around pipe at center of levee. Siphon breaker at landward shoulder.

Slant pump on waterward side with staircase access. Discharge structure at landward toe. Rock revetment on waterward slope. (Permit No. 11744-1976)					
FS Date: 3/19/2009

Pump system located on waterward side.

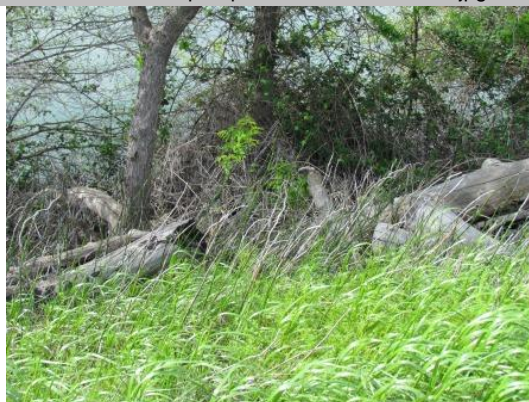
Photo 1 of 1 : phillips\_s\_20140521\_05926.jpg

LM Start	1.48	Rating **	U	Issue No.	64
LM End	1.48	Issue Type +	En	Location *	WS
Category	Earthen Levee			GPS Latitude/Longitude	
				Start	End
Item	Encroachments			38.275332 °	38.275332 °
				-121.601359 °	-121.601359 °
DWR ID	DWR_RD0349_03_s _ 2014_64				
Action/Comments					
Tree or limb					
Inspector Comments: Cut up tree on waterward slope.

Cut up fallen tree on waterside slope.

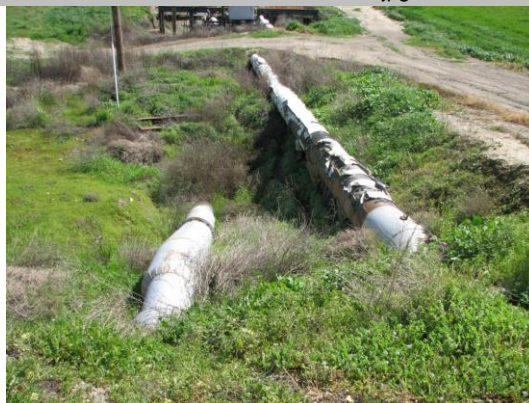
Photo 1 of 1 : UCIP\_2636.jpg

UCIP Comments: Dense vegetation limits the inspector's visibility to identify signs of pipe failure (leaks) along the slope. Recommend removing vegetation along pipe alignment to conduct proper inspection of structure and appurtenances. Note date on photos should be 3/18/09 not 7/26/08 camera metadata is incorrect.

View of pipe daylight point on landward side.

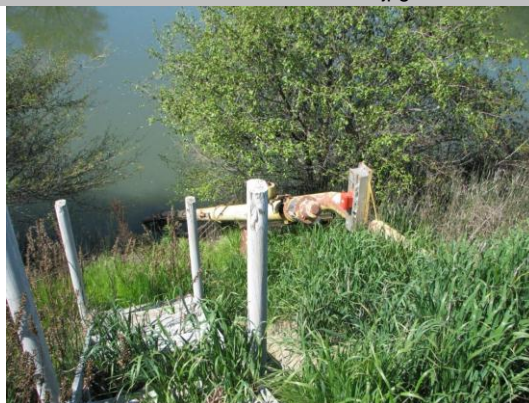
Photo 1 of 1 : UCIP\_2643.jpg

Action/Comments					
Inspector Comments: FS_ID:21633					
EP_NO: N/A					
Repair Type:					
Crossing Status:					
UCIP Comments: Dense vegetation limits the inspector's visibility to identify signs of pipe failure (leaks) through the levee slopes. Recommend removing vegetation along pipe alignment to conduct proper inspection of structure and appurtenances. Note date on photos should be 3/18/09 not 7/26/08 camera metadata is incorrect.					
FIELD_STRUCT_DESC: 2 of 2: 12-inch pipe and 2-inch electrical conduit through the levee, both 8.0 feet below the crown. Siphon breaker in pipe riser on landward slope. Concrete standpipe at landward toe. Pump on waterward side with stairway access.					
FS Date: 3/19/2009

View of waterward side--pump, pipe, control panel, and stairway.

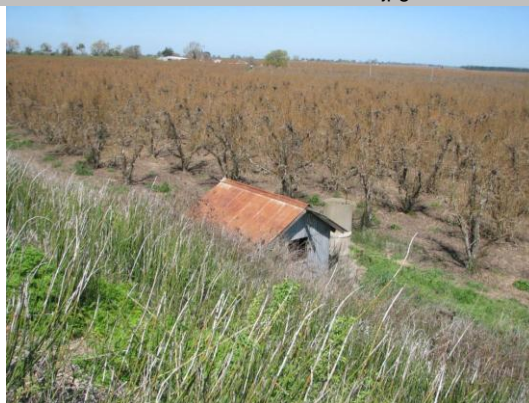
Photo 1 of 1 : UCIP\_2646.jpg

UCIP Comments: Dense vegetation limits the inspector's visibility to identify signs of pipe failure (leaks) through the levee slopes.

Recommend removing vegetation along pipe alignment to conduct proper inspection of structure and appurtenances. Note date on photos should be 3/18/09 not 7/26/08 camera metadata is incorrect.

View of landward side--pump house and stand pipe.

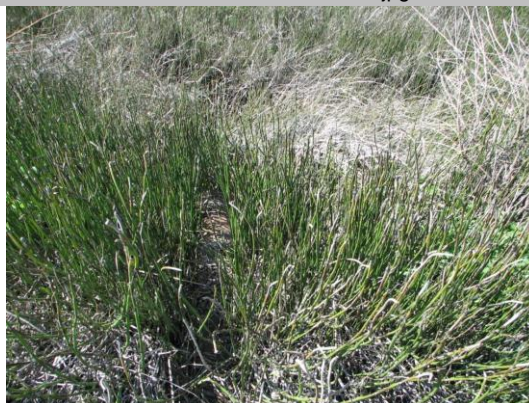
Photo 1 of 1 : UCIP\_2727.jpg

LM Start	2.59	Rating **	M	Issue No.	45
LM End	2.59	Issue Type +	En	Location *	WS
Category	Supplemental			GPS Latitude/Longitude	
				Start	End
Item	DWR UCIP Field Study			38.289760 °	38.289760 °
				-121.603280 °	-121.603280 °
DWR ID	DWR_RD0349_03_s _ 2014_45

Inspector Comments: FS\_ID:21678  
 EP\_NO: N/A  
 Repair Type:  
 Crossing Status:  
 UCIP Comments: Need to contact owner--If crossing is no longer used by owner, the owner will need to coordinate with DWR Inspector and CVFPB to remove crossing according to Title 23 requirements. Dense vegetation limits the inspector's visibility to identify signs of pipe failure (leaks) through the levee slopes. Recommend removing vegetation along pipe alignment to conduct proper inspection of structure and appurtenances. Note date on photos should be 3/18/09 not 7/26/08 camera metadata is incorrect.  
 FIELD\_STRUCT\_DESC: Abandoned 10-inch pipe through the levee, 8.2 feet below the crown. Pipe has plate welded on the waterward end. 3-inch galvanized pipe runs parallel to 10-inch pipe. Abandoned tank on waterward slope. Distribution box and concrete standpipe at landward toe. (USACE-1959). This entry matches the Drainage or Irrigation Structure referenced in O&M manual (HLM 2.7).

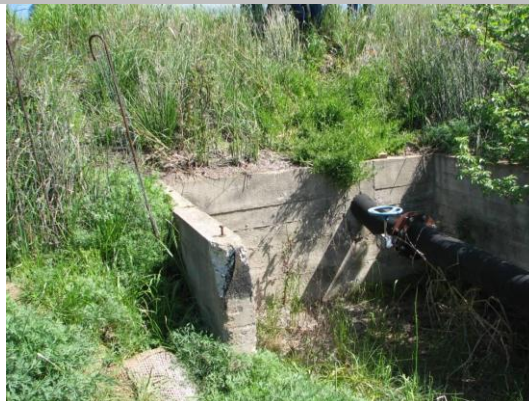
Photo 1 of 1 : UCIP\_2732.jpg

LM Start	2.78	Rating **	M	Issue No.	46
LM End	2.78	Issue Type +	En	Location *	WS
Category	Supplemental			GPS Latitude/Longitude	
				Start	End
Item	DWR UCIP Field Study			38.292421 °	38.292421 °
				-121.603698 °	-121.603698 °
DWR ID	DWR_RD0349_03_s _ 2014_46				
Action/Comments					
Inspector Comments: FS_ID:21679					
EP_NO: N/A					
Repair Type:					
Crossing Status:					
UCIP Comments: 2007 Erosion Repair Site location?--Need to contact owner to determine if crossing is still in use. If crossing is no longer used by owner, the owner will need to coordinate with DWR Inspector and CVFPB to remove crossing according to Title 23 requirements. Dense vegetation limits the inspector's visibility to identify signs of pipe failure (leaks) through the levee slopes. Recommend removing vegetation along pipe alignment to conduct proper inspection of structure and appurtenances. Note date on photos should be 3/18/09 not 7/26/08 camera metadata is incorrect.

FIELD_STRUCT_DESC: Abandoned 8-inch pipe through the levee, 8.7 feet below the crown. Headwall and gate valve on the landward side.					
FS Date: 3/19/2009

View of waterward side--headwall, pipe, and gate valve.

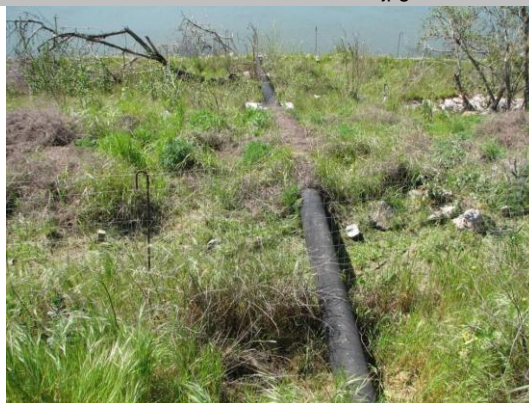
Photo 1 of 1 : UCIP\_2664.jpg

LM Start	2.90	Rating **	M	Issue No.	47
LM End	2.90	Issue Type +	En	Location *	WS
Category	Supplemental			GPS Latitude/Longitude	
				Start	End
Item	DWR UCIP Field Study			38.294140 °	38.294140 °
				-121.604268 °	-121.604268 °
DWR ID	DWR_RD0349_03_s_2014_47				
Action/Comments					
Inspector Comments: FS_ID:21641					
EP_NO: N/A					
Repair Type:					
Crossing Status:					
UCIP Comments: 2007 Erosion Repair Site location?--Need to contact owner to determine if crossing is still in use. If crossing is no longer used by owner, the owner will need to coordinate with DWR Inspector and CVFPB to remove crossing according to Title 23 requirements. Dense vegetation limits the inspector's visibility to identify signs of pipe failure (leaks) through the levee slopes. Recommend removing vegetation along pipe alignment to conduct proper inspection of structure and appurtenances. Note date on photos should be 3/18/09 not 7/26/08 camera metadata is incorrect.

FIELD_STRUCT_DESC: 8-inch pipe through the levee, 3.7 feet below the crown. Pump and gate valve on the waterward side. (USACE-1959). This entry matches the Drainage or Irrigation Structure referenced in O&M manual (HLM 2.9).					
FS Date: 3/19/2009

View of pipe along slope--repair site.

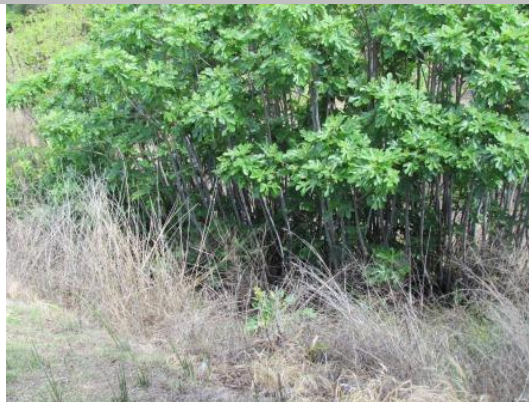
Photo 1 of 1 : phillips\_s\_20140521\_05928.jpg

LM Start	3.30	Rating **	U	Issue No.	69
LM End	3.30	Issue Type +	Ma	Location *	LS
Category	Earthen Levee			GPS Latitude/Longitude	
				Start	End
Item	Vegetation			38.299140 °	38.299140 °
				-121.601992 °	-121.601992 °
DWR ID	DWR_RD0349_03_s _ 2014_69				
Action/Comments					
Trees / Woody Vegetation					
Inspector Comments: Remove the thick growth of fig tres at landward toe and slope.

Wild growth of fig trees on the landside of the levee toe.

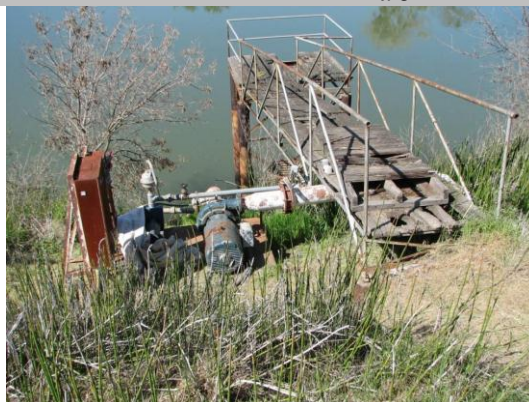
Photo 1 of 1 : UCIP\_2734.jpg

LM Start	3.36	Rating **	M	Issue No.	48
LM End	3.36	Issue Type +	En	Location *	LS
Category	Supplemental			GPS Latitude/Longitude	
				Start	End
Item	DWR UCIP Field Study			38.299762 °	38.299762 °
				-121.601167 °	-121.601167 °
DWR ID	DWR_RD0349_03_s _ 2014_48				
Action/Comments					
Inspector Comments: FS_ID:21680					
EP_NO: N/A					
Repair Type:					
Crossing Status:					
UCIP Comments: Crossing altered--need to contact owner to obtain permit number authorizing work. Dense vegetation limits the inspector's visibility to identify signs of pipe failure (leaks) along the slope. Recommend removing vegetation along pipe alignment to conduct proper inspection of structure and appurtenances. Note date on photos should be 3/18/09 not 7/26/08 camera metadata is incorrect. FIELD_STRUCT_DESC: 10-inch (not 12-inch) pipe through the levee, 6.2 feet below the crown. Two pumps located on waterward slope (not on piling structure as originally noted) and gate valve on the waterward side, walkway to pump. Service pole on the landward slope and concrete distribution box at landward toe. New appurtenance--filtraton system located on landward toe.

View of waterward side--pump, control panel, pipe, and walkway.

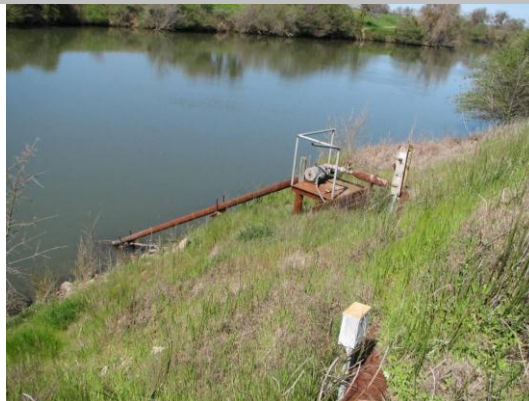
Photo 1 of 1 : UCIP\_2672.jpg

LM Start	3.80	Rating **	M	Issue No.	49
LM End	3.80	Issue Type +	En	Location *	LS
Category	Supplemental			GPS Latitude/Longitude	
				Start	End
Item	DWR UCIP Field Study			38.305300 °	38.305300 °
				-121.598620 °	-121.598620 °
DWR ID	DWR_RD0349_03_s_2014_49

UCIP Comments: Dense vegetation limits the inspector's visibility to identify signs of pipe failure (leaks) through the levee slopes.

Recommend removing vegetation along pipe alignment to conduct proper inspection of structure and appurtenances.

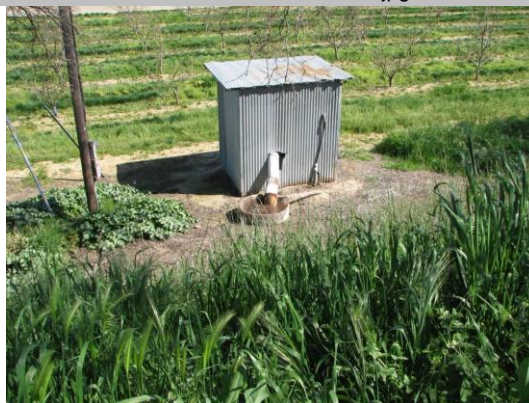
Photo 1 of 1 : UCIP\_2675.jpg

UCIP Comments: Dense vegetation limits the inspector's visibility to identify signs of pipe failure (leaks) through the levee slopes.

Recommend removing vegetation along pipe alignment to conduct proper inspection of structure and appurtenances. Note date on photos should be 3/18/09 not 7/26/08 camera metadata is incorrect.

Pump house located on landward side.

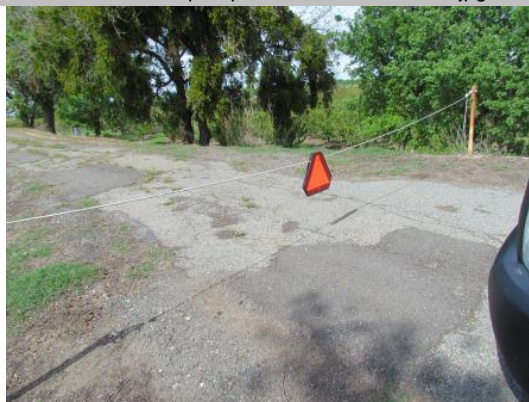
Photo 1 of 1 : phillips\_s\_20140521\_05929.jpg

LM Start	4.07	Rating **	U	Issue No.	25
LM End	4.07	Issue Type +	En	Location *	CR
Category	Earthen Levee			GPS Latitude/Longitude	
				Start	End
Item	Encroachments			38.307997 °	38.307997 °
				-121.597039 °	-121.597039 °
DWR ID	DWR_RD0349_03_s _ 2012_25				
Action/Comments					
Fence Inspector Comments: Unauthorized cable gate crossing levee. Cable gates crossing the levee crown have been prohibited. There is no CVFPB Permit for this crossing.

Cable crossings has been banned by the CORE. They are unauthorized.

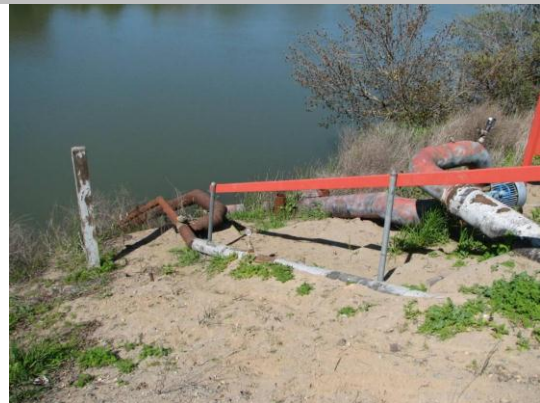
Photo 1 of 1 : UCIP\_2676.jpg

LM Start	4.29	Rating **	M	Issue No.	51
LM End	4.29	Issue Type +	En	Location *	LS
Category	Supplemental			GPS Latitude/Longitude	
				Start	End
Item	DWR UCIP Field Study			38.310911 °	38.310911 °
				-121.596198 °	-121.596198 °
DWR ID	DWR_RD0349_03_s _ 2014_51				
Action/Comments					
Inspector Comments: FS_ID:21646 EP_NO: 8681 Repair Type: Crossing Status: UCIP Comments: Need to contact owner to determine status of crossing. If crossing is no longer in use owner will need to coordinate with DWR inspector and CVFPB to remove according to Title 23 requirements. Dense vegetation limits the inspector's visibility to identify signs of pipe failure (leaks) through the levee slopes. Recommend removing vegetation along pipe alignment to conduct proper inspection of structure and appurtenances. Note date on photos should be 3/18/09 not 7/26/08 camera metadata is incorrect. FIELD_STRUCT_DESC: 1 of 2: 6-inch steel pipe and 1.5-inch steel electrical conduit through the levee, 4.1 feet and 2.0 feet below the crown, respectively. Steel cutoff wall around pipe and conduit at center of levee. Pump on platform and gate valve on the waterward slope, not connected. Exposed suction pipe from pump to channel. Rock revetment on waterward slope. (Permit No. 8681-1973) FS Date: 3/19/2009

View of waterward side. 2 crossing visible 12-inch and 6-inch pipes.

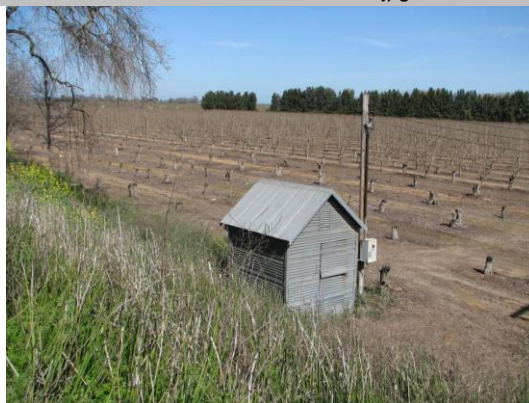
Photo 1 of 1 : UCIP\_2690.jpg

View of landward side.

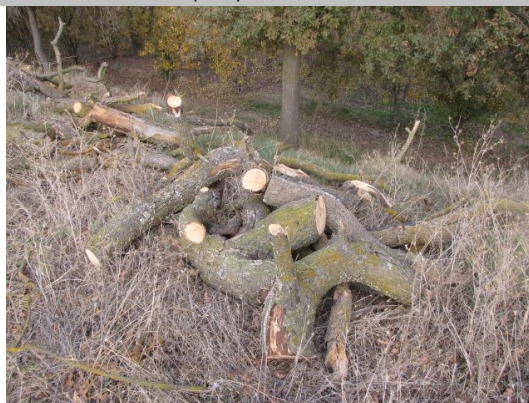
Photo 1 of 1 : phillips\_s\_20140306\_812.JPG

LM Start	5.11	Rating **	U	Issue No.	30
LM End	5.11	Issue Type +	En	Location *	LS
Category	Earthen Levee			GPS Latitude/Longitude	
				Start	End
Item	Encroachments			38.320831 °	38.320831 °
				-121.589637 °	-121.589637 °
DWR ID	DWR_RD0349_03_f_2013_30				
Action/Comments					
Tree or limb

Firewood on landward slope and toe. Photo taken 11-14-2013. No change no new photo taken.

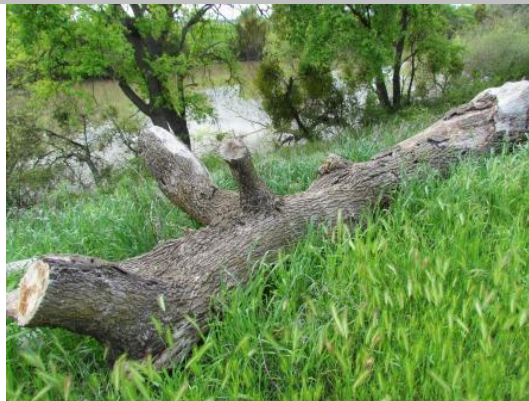
Photo 1 of 1 : phillips\_s\_20140521\_05933.jpg

LM Start	5.11	Rating **	U	Issue No.	81
LM End	5.11	Issue Type +	En	Location *	WS
Category	Earthen Levee			GPS Latitude/Longitude	
				Start	End
Item	Encroachments			38.320775 °	38.320775 °
				-121.589643 °	-121.589643 °
DWR ID	DWR_RD0349_03_s_2014_81				
Action/Comments					
Tree or limb

Dead tree on the waterside slope.

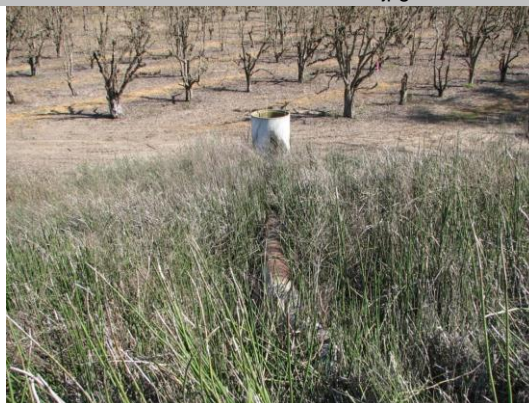
Photo 1 of 1 : UCIP\_2703.jpg

View of landwar side--pipe and stand pipe visible.

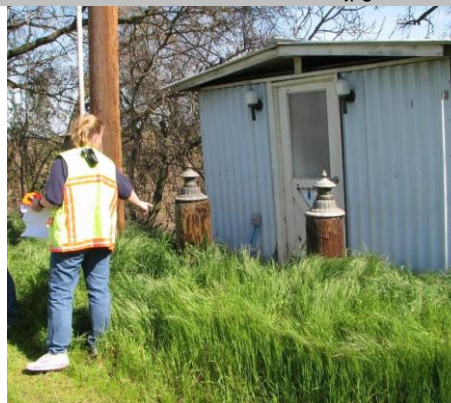
Photo 1 of 1 : UCIP\_2705.jpg

View of structure on landward shoulder.

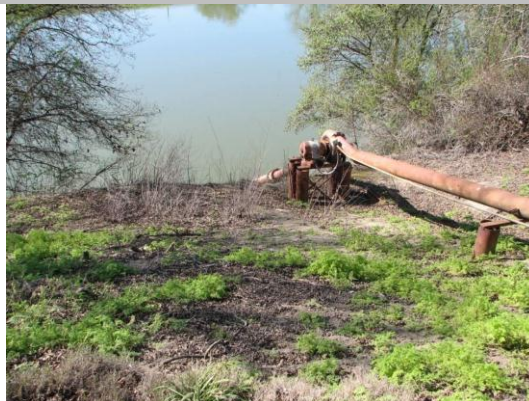
Photo 1 of 1 : UCIP\_2708.jpg

DWM Start	5.62	Rating **	M	Issue No.	57
LM End	5.62	Issue Type +	En	Location *	LS
Category	Supplemental			GPS Latitude/Longitude	
				Start	End
Item	DWR UCIP Field Study			38.326030 °	38.326030 °
				-121.584830 °	-121.584830 °
DWR ID	DWR_RD0349_03_s _ 2014_57				
Action/Comments					
Inspector Comments: FS_ID:21670					
EP_NO: 16077					
Repair Type:					
Crossing Status:					
UCIP Comments: Soil disturbed on landward slope--need to contact owner. Also vegetation limits the inspector's visibility to identify signs of pipe failure (leaks) along the slope. Recommend removing vegetation along pipe alignment to conduct proper inspection of structure and appurtenances. Note date on photos should be 3/18/09 not 7/26/08 camera metadata is incorrect.					
FIELD_STRUCT_DESC: 10-inch pipe through the levee, 3.8 feet below the crown. Pump in pumphouse on waterward side. Service pole on waterward slope. Concrete standpipe and distribution box at waterward toe. Pipe is exposed on both slopes. (USACE-1959). This entry matches the Drainage or Irrigation Structure referenced in O&M manual (HLM 5.9). Section of pipe under crown, between shoulders, removed and replaced with 10-inch steel pipe under Permit No. 16077 (2000).

View of pipe and pump along waterward slope.

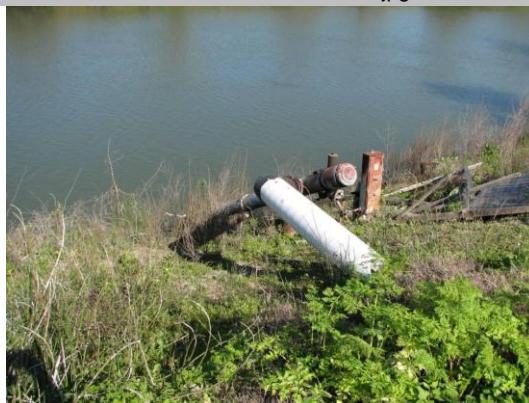
Photo 1 of 1 : UCIP\_2709.jpg

LM Start	6.36	Rating **	M	Issue No.	58
LM End	6.36	Issue Type +	En	Location *	LS
Category	Supplemental			GPS Latitude/Longitude	
				Start	End
Item	DWR UCIP Field Study			38.328944 °	38.328944 °
				-121.579219 °	-121.579219 °
DWR ID	DWR_RD0349_03_s_2014_58				
Action/Comments					
Inspector Comments: FS_ID:21671					
EP_NO: 17765					
Repair Type:					
Crossing Status:					
UCIP Comments: Need to contact owner. Debris found on waterward side--needs to be removed. Also dense vegetation limits the inspector's visibility to identify signs of pipe failure (leaks) along the slope. Recommend removing vegetation along pipe alignment to conduct proper inspection of structure and appurtenances. Note date on photos should be 3/18/09 not 7/26/08 camera metadata is incorrect.					
FIELD_STRUCT_DESC: 12-inch steel irrigation pipe through the levee, 6.3 feet below the crown. Slant pump on concrete pilings on waterward slope. Concrete standpipe, distribution box and electric service pole at landward toe. Pipe exposed on landward slope. (Permit No. 17765-2004)

View of waterward side--pipe, pump, and control panels.
